Rimkus Consulting Group, Inc.
Eight Greenway Plaza, Suite 500
Houston, TX 77046
(800) 580-3228 Telephone
(713) 623-4357 Facsimile

Re: RCG File No: 11009971
LLV Number: 0209452
VMF Location: 1530 Greensmark Drive in Houston, Texas
Subject: Final Report

Rimkus Consulting Group, Inc. was retained to examine LLV 0209452, VIN 1GBCS10E4M2908832. The fire occurred on June 13, 2016 at around 12:30 P.M. the operator of the vehicle at the time of the fire, was unavailable for interview but reportedly stated the vehicle's engine died while delivering mail on his route and backfired during subsequent attempts to restart it. Soon thereafter, smoke was observed from beneath the hood as well as flames.

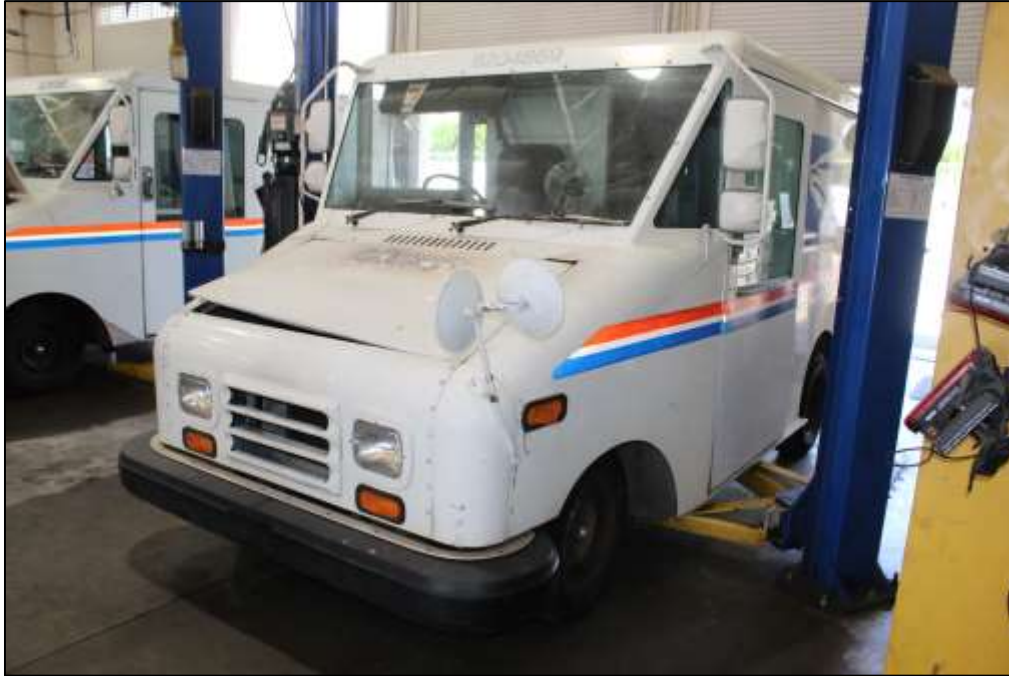
Photograph 1
Subject LLV 9204869

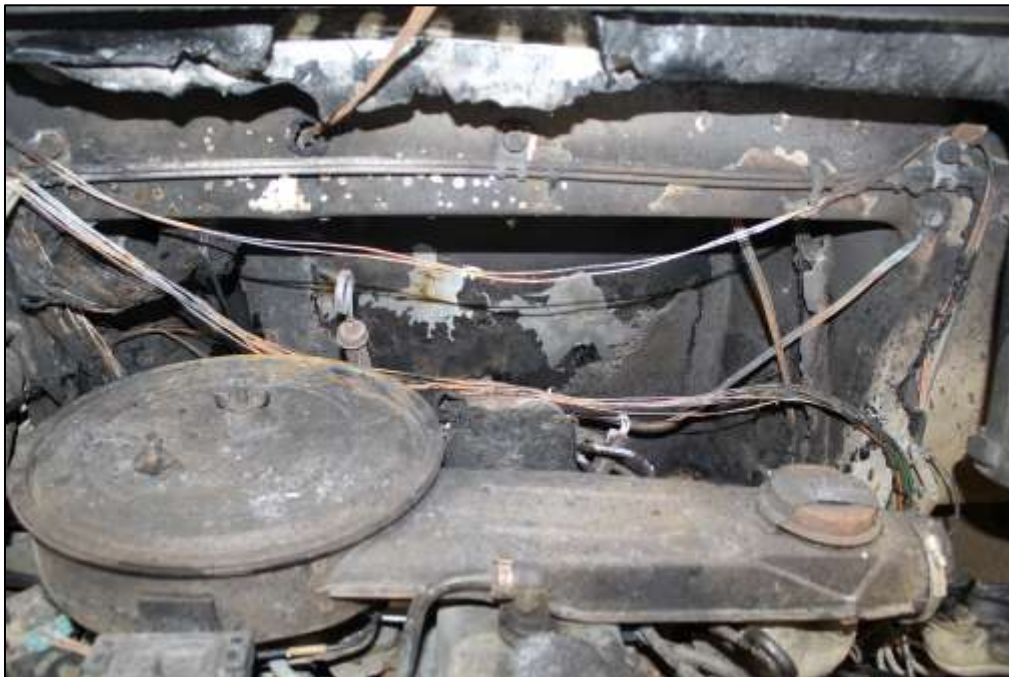
Photograph 2
Fire entered engine compartment from low level at rear of engine.

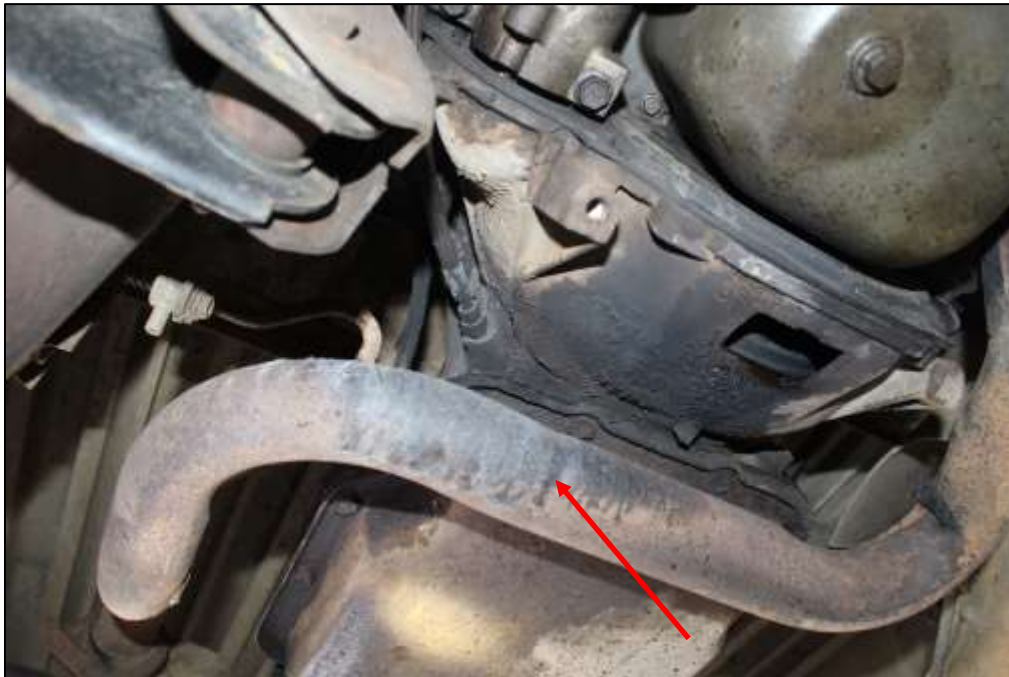
Photograph 3

Area of origin: Note fluid stains on exhaust pipe (red arrow) from the transmission.

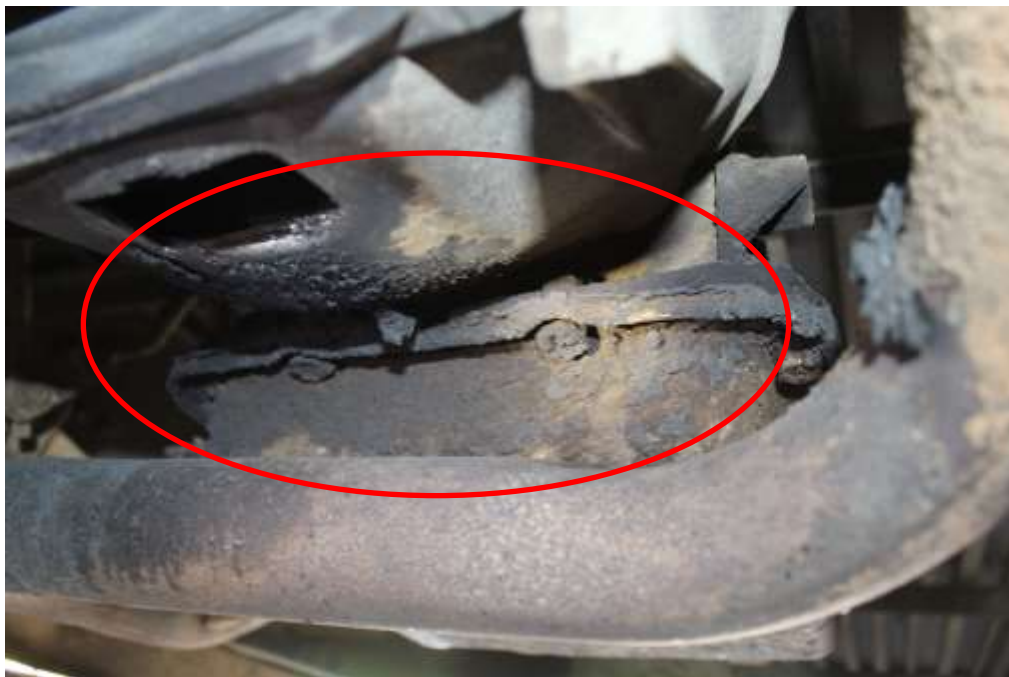
Photograph 4

Charred fluid build-up at front of transmission.

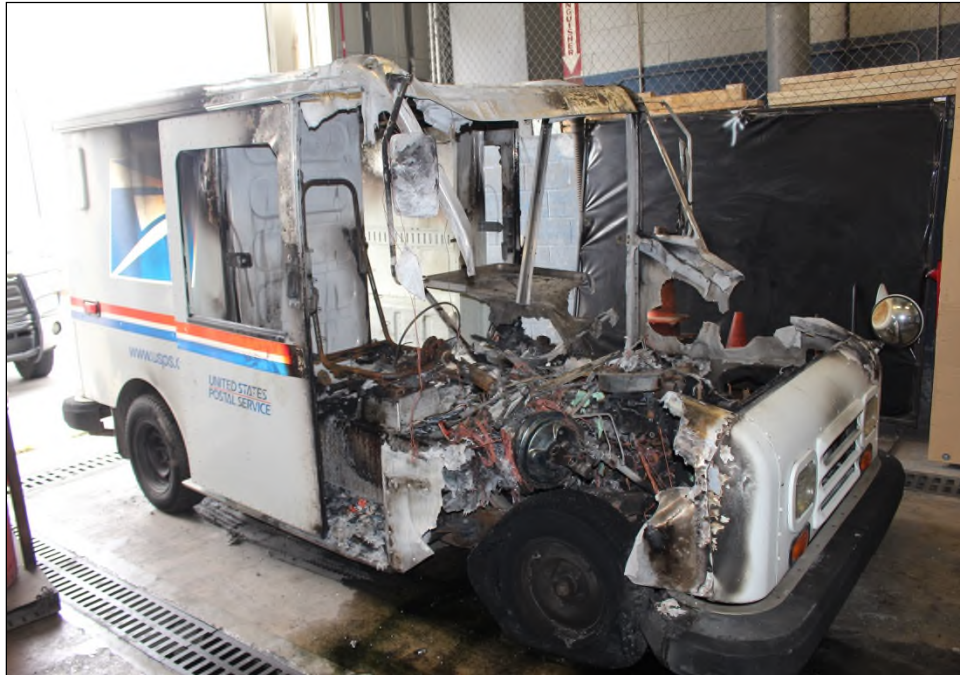
Photograph 1

Front and right side view of the vehicle.

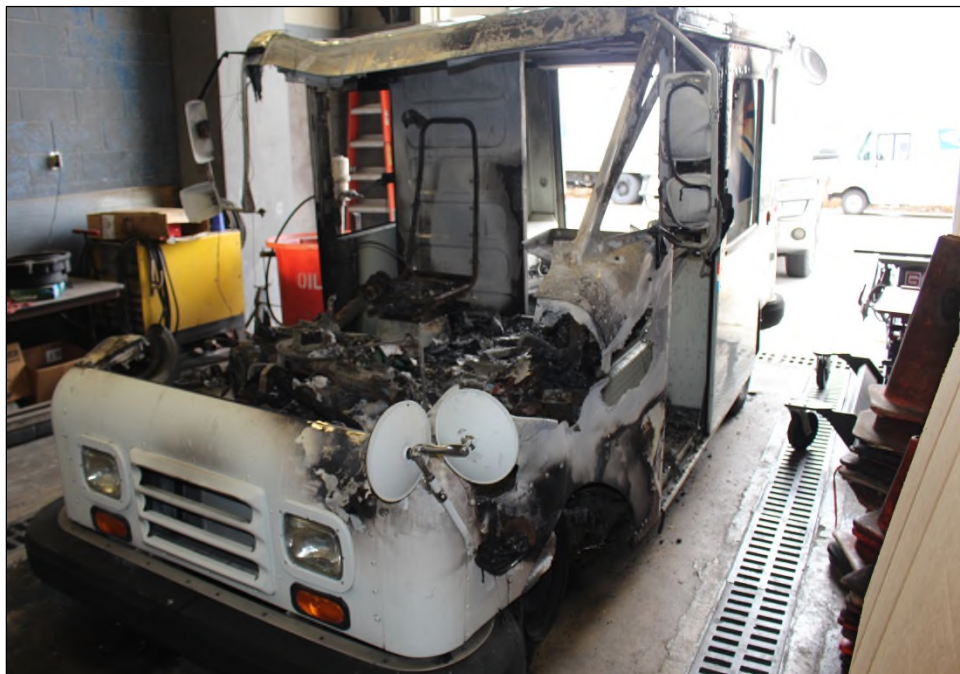
Photograph 2

Front and a portion of the left side view of the vehicle.

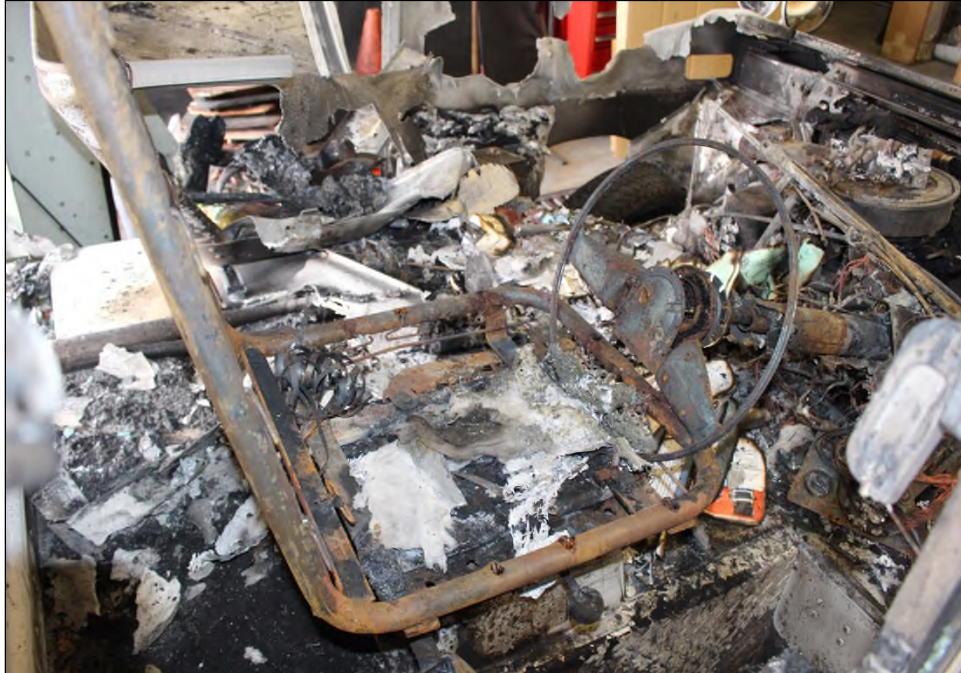
Photograph 3

View showing the driver's compartment.

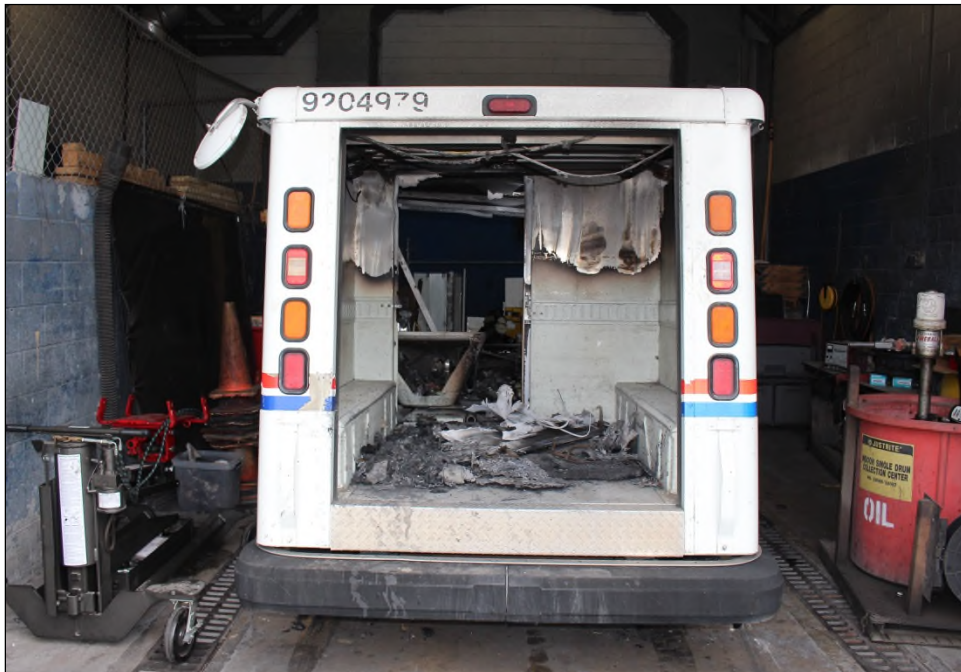
Photograph 4

View of the rear cargo area of the vehicle.

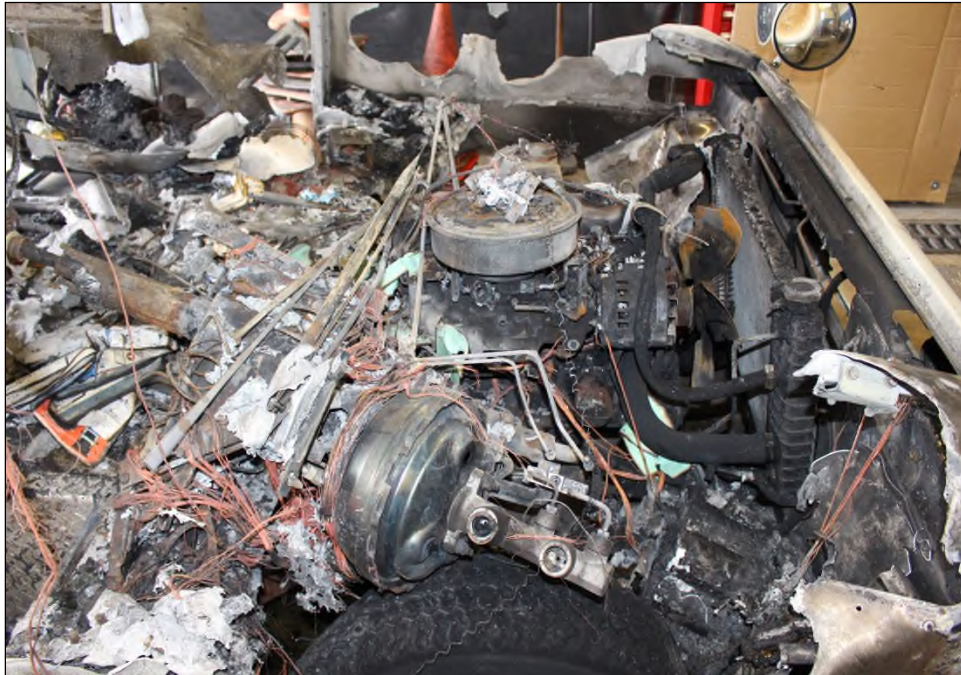
Photograph 5

View showing the right side of the engine compartment.

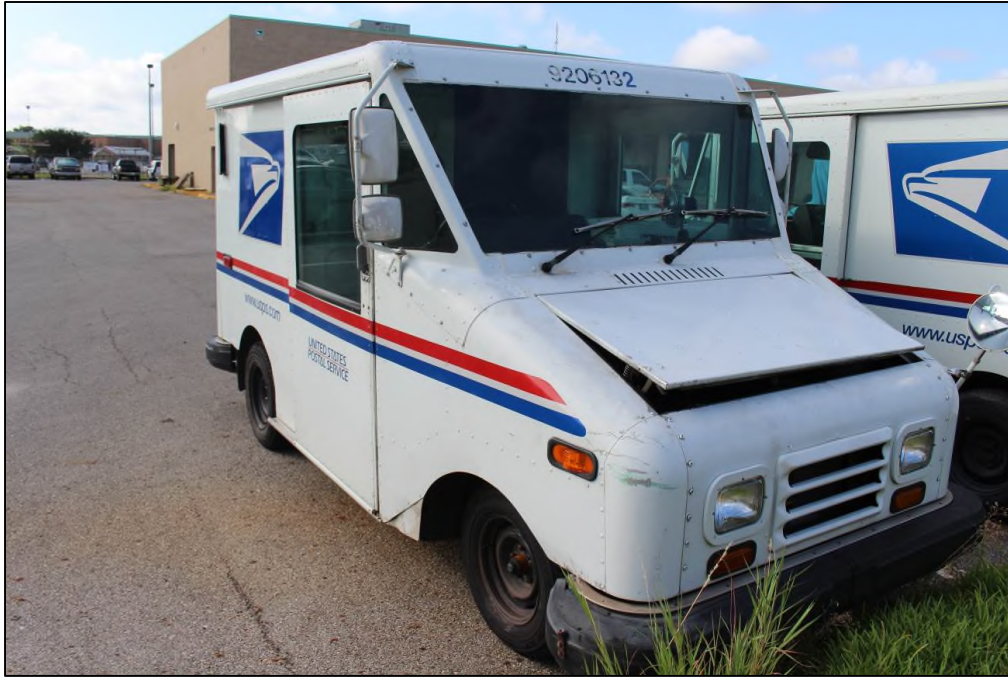
Photograph 1

Exterior view of unit from front driver side.

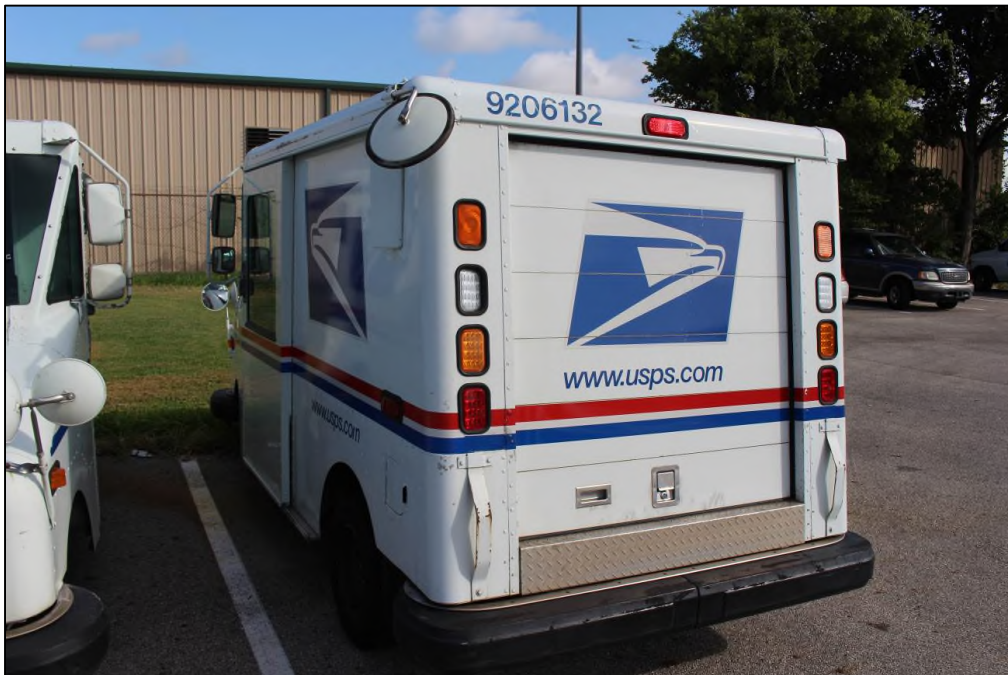
Photograph 2

Exterior view of unit from rear passenger side.

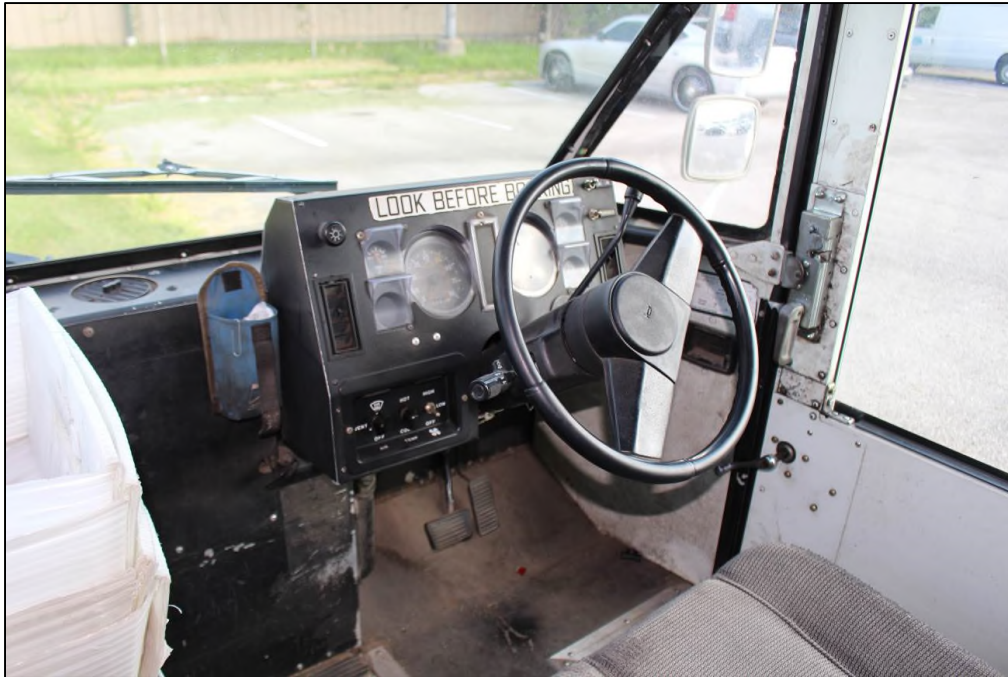
Photograph 3

The interior operator compartment of the LLV was examined and was intact. There was no observable physical evidence on the interior operator and mail area of fire damage.

View of interior of unit.

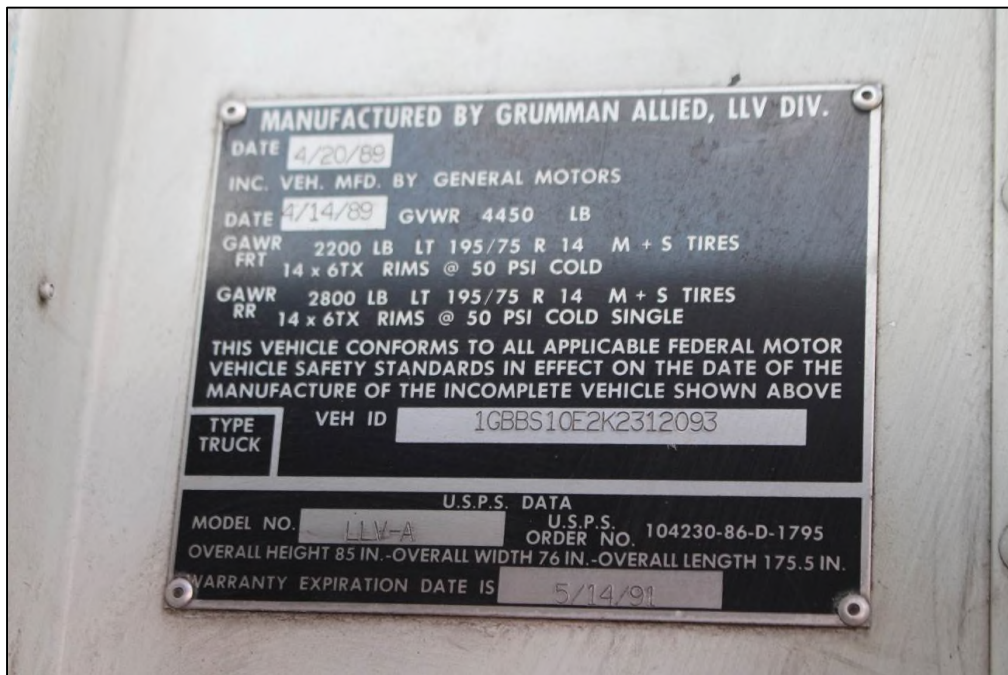
Photograph 4

Vehicle identification label in interior of unit.

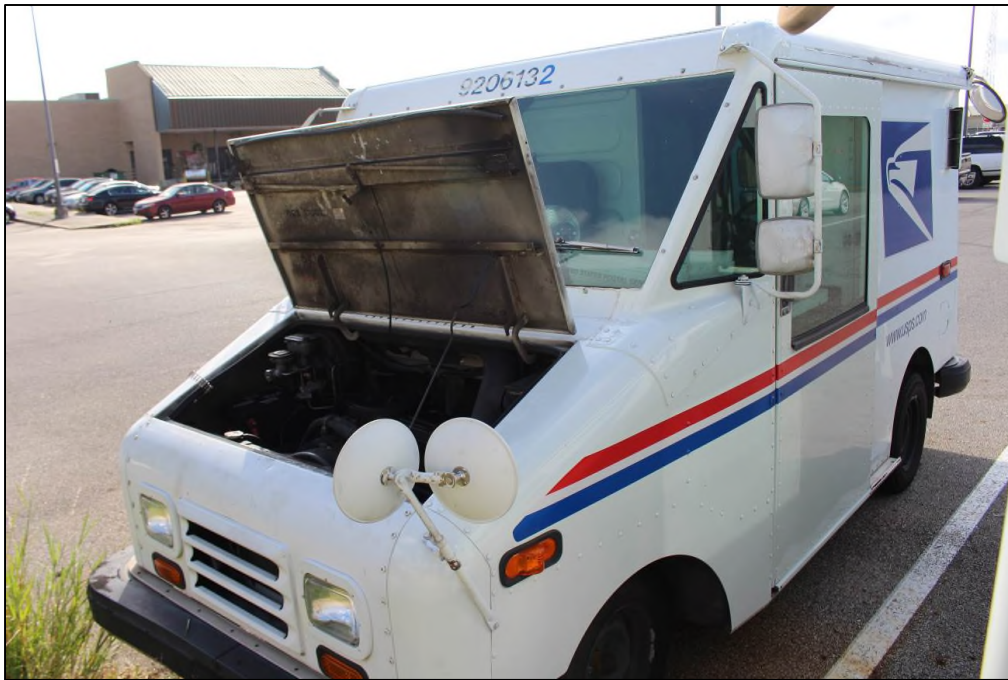
Photograph 5

Engine cover raised to examine and document fire damage inside engine compartment.

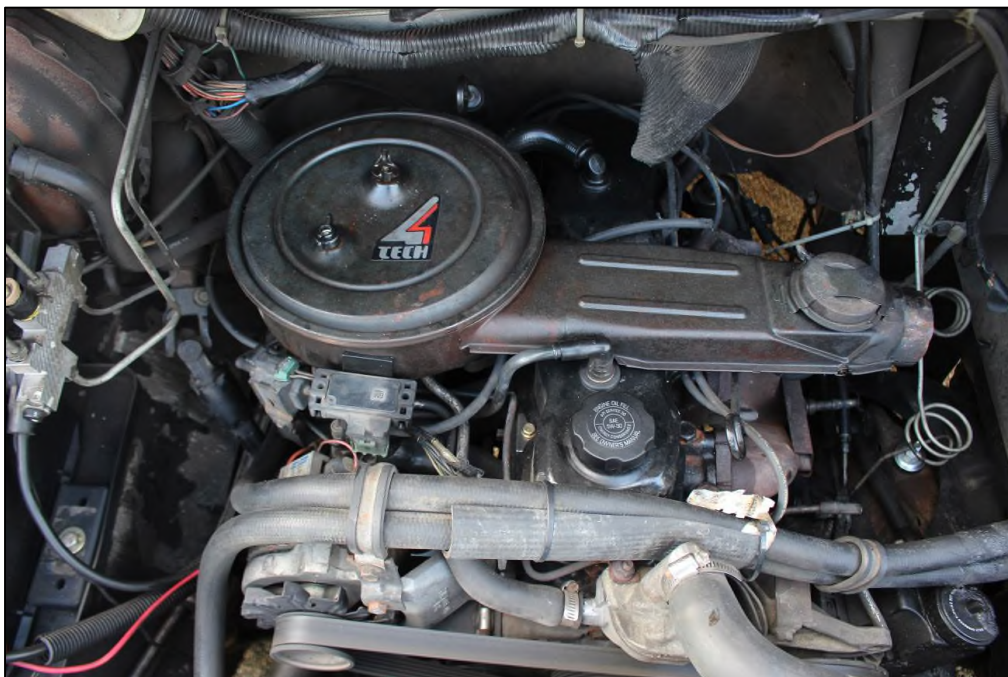
Photograph 6

View of engine compartment.

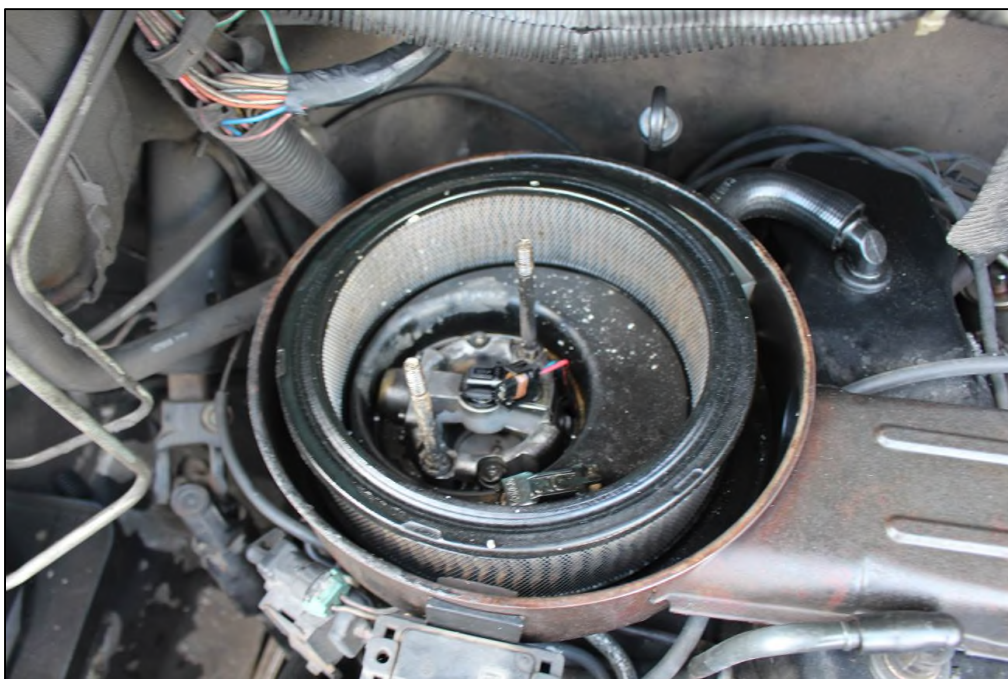
Photograph 8

Removal of the air filter cover on top of the engine revealed evidence of elevated heat inside the filter assembly and excessive oil. The texture of the oil was frothy and its color creamy indicative of the presence of water. The oil level observed on the dipstick was in excess of normal level and the oils appearance was also frothy and cream colored.

Air filter access cover removed to show excess oil and heat stress inside the filter assembly.

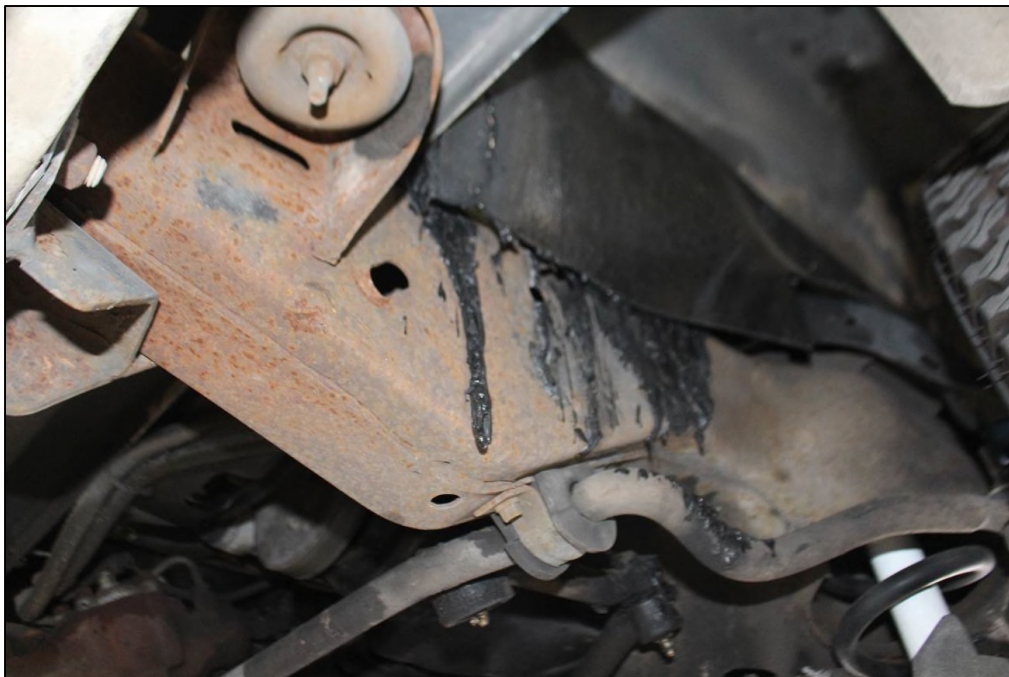
Photograph 10

Melted rubber and synthetic material that dripped down on frame below the engine during the brief fire.

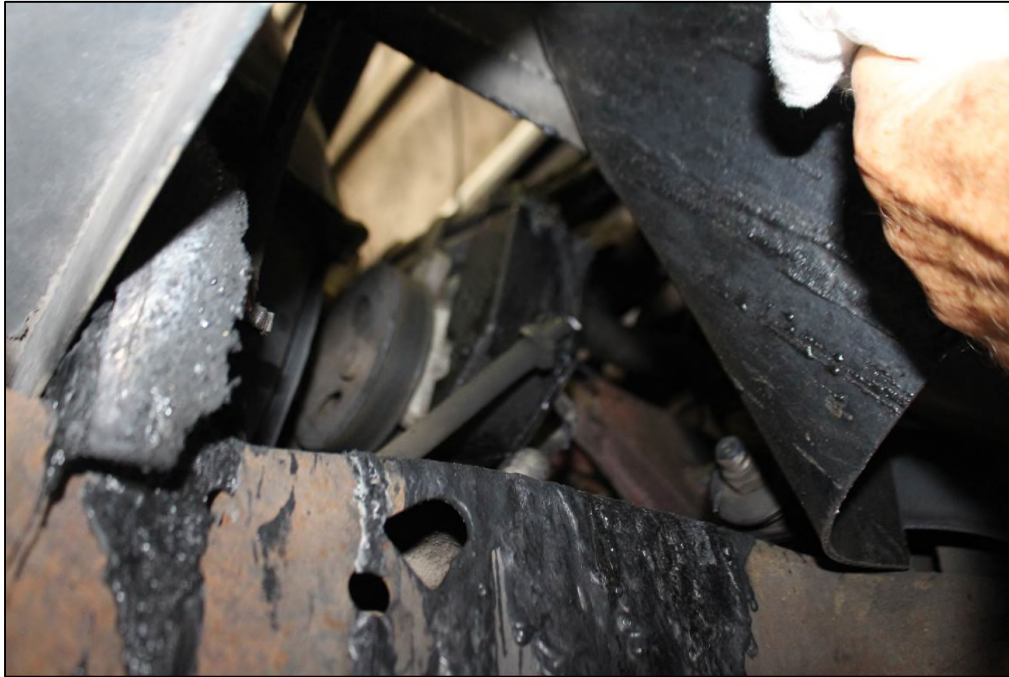
Photograph 11

Closer view of melted remains of rubber and synthetic materials inside engine compartment below engine.

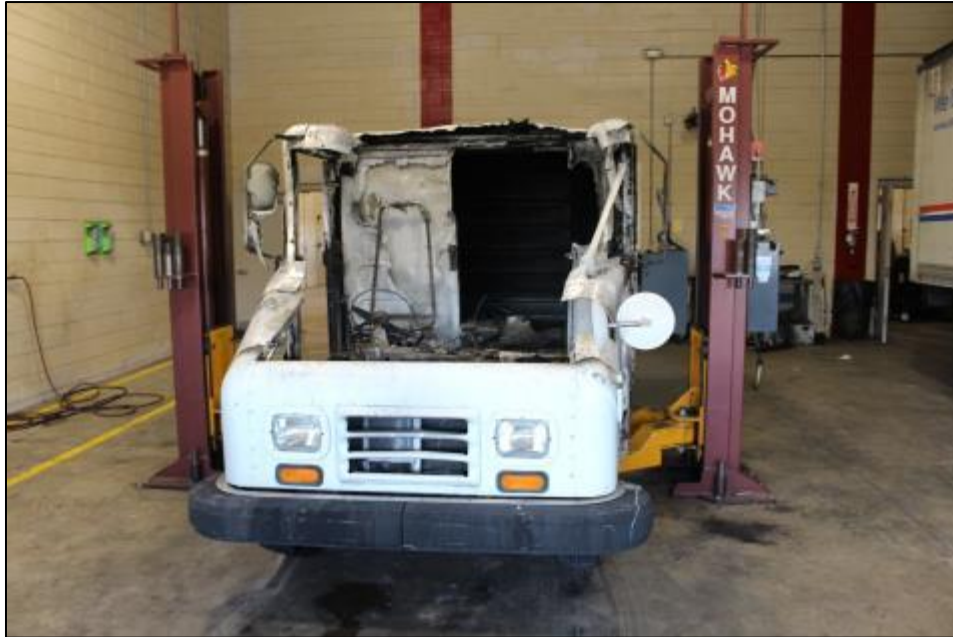
Photograph 1
Front of vehicle.

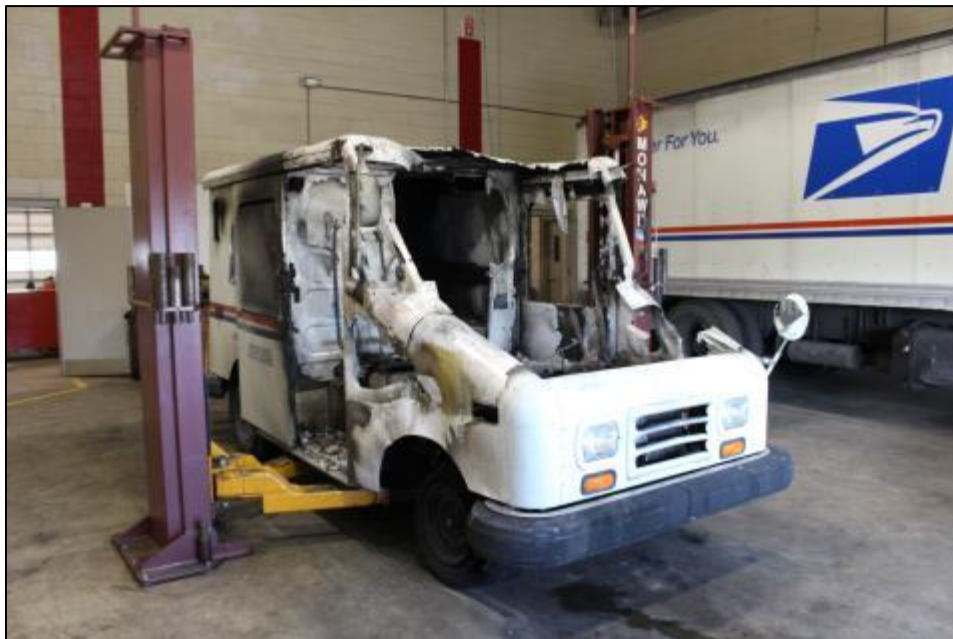
Photograph 2
Front right side.

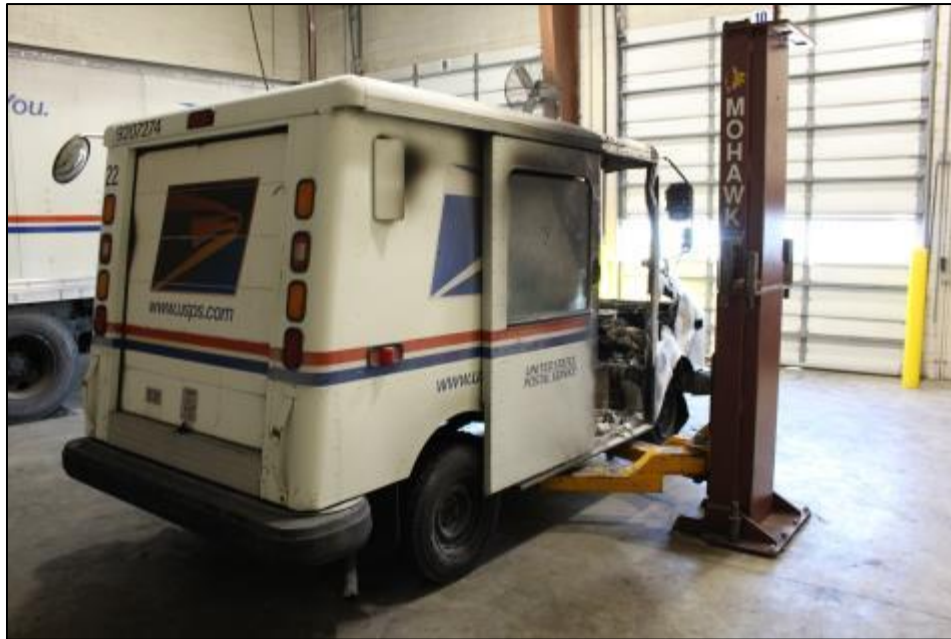
Photograph 3
Right rear side.

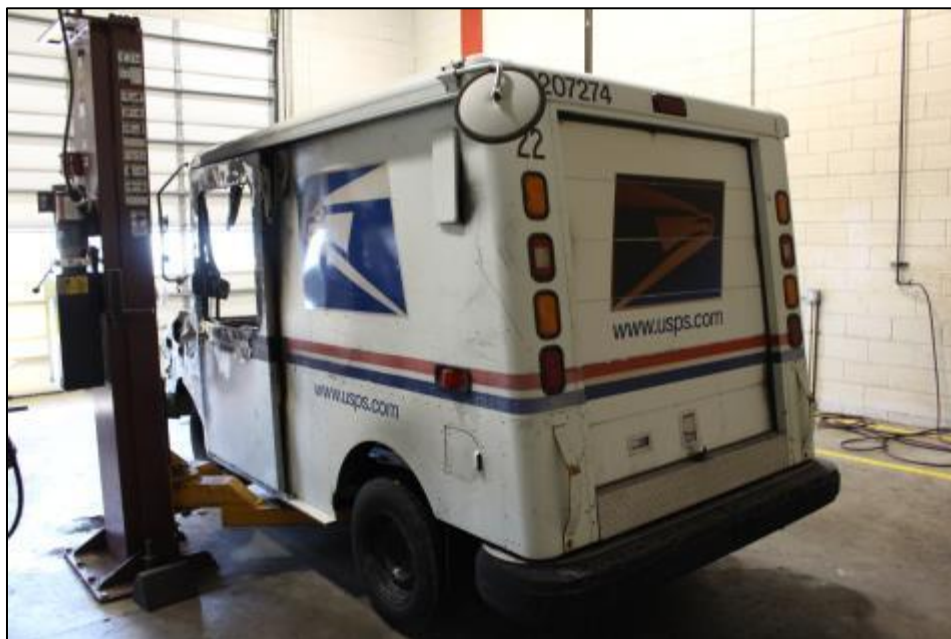
Photograph 4
Left rear side.

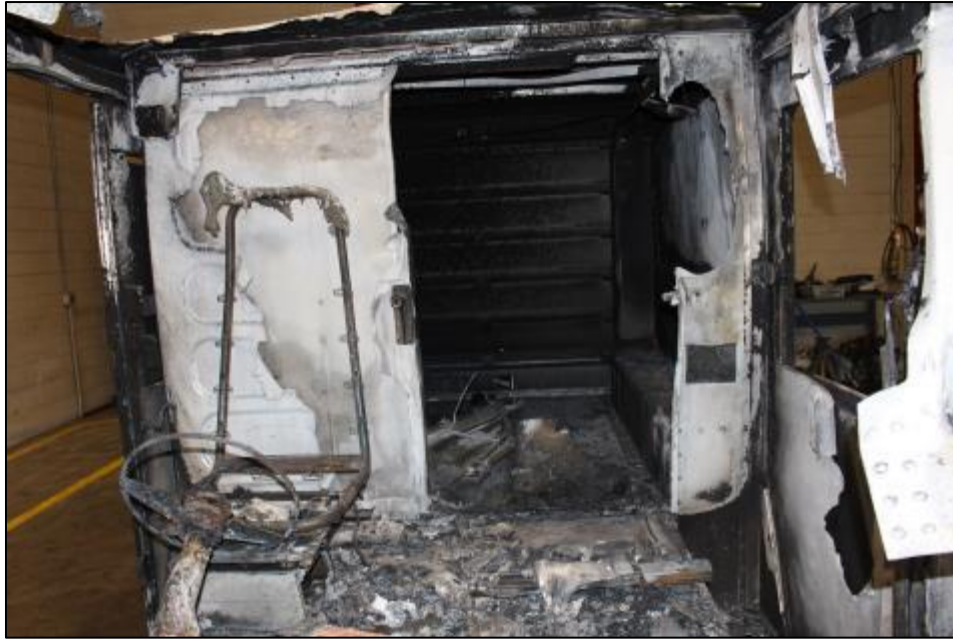
Photograph 5
View from front.

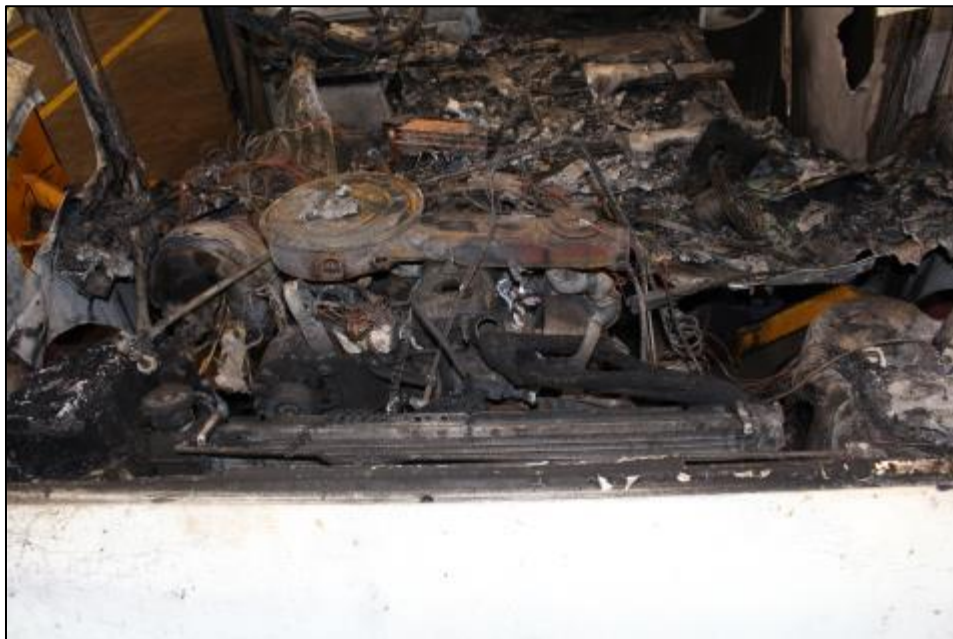
Photograph 6
Overall engine compartment.

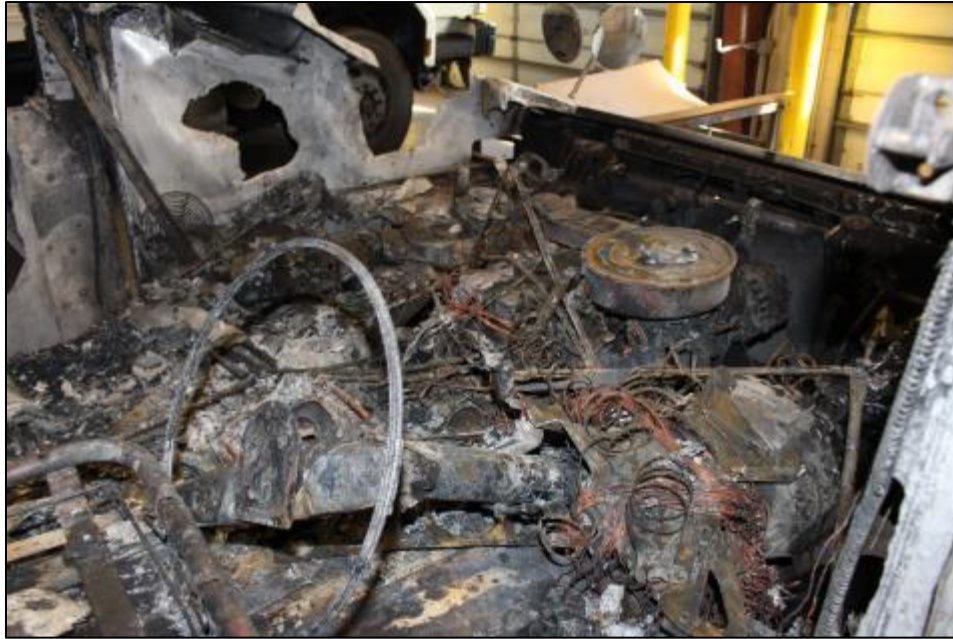
Photograph 7
Driver's area.

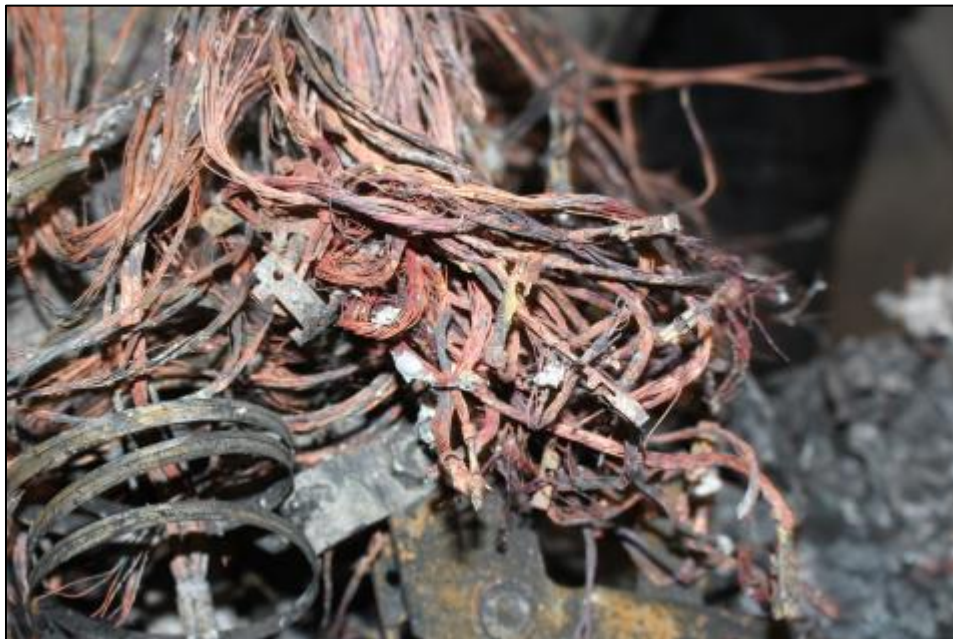
Photograph 8
Wiring for fuse panel.

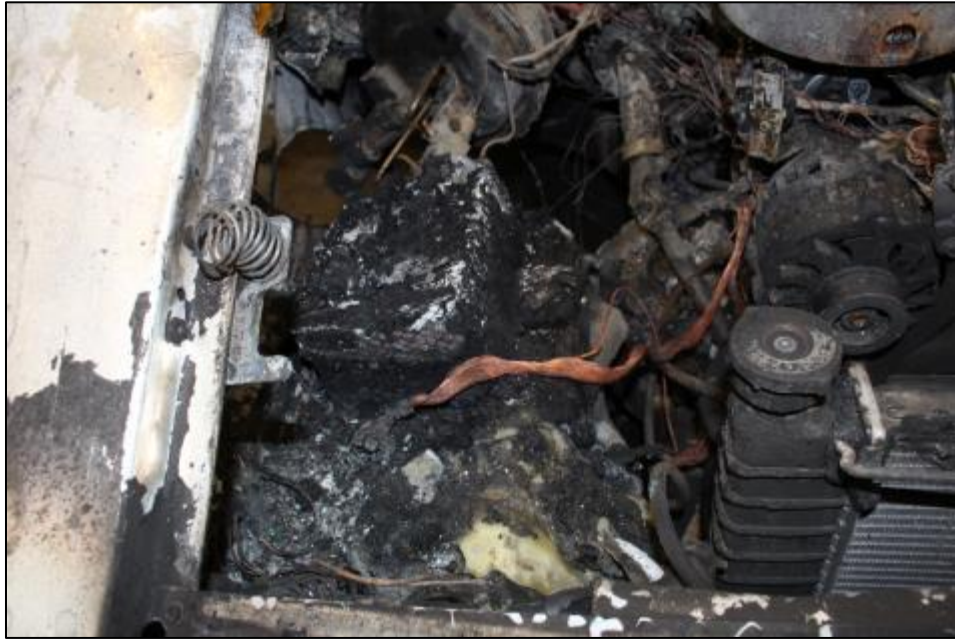
Photograph 9
Remains of battery.

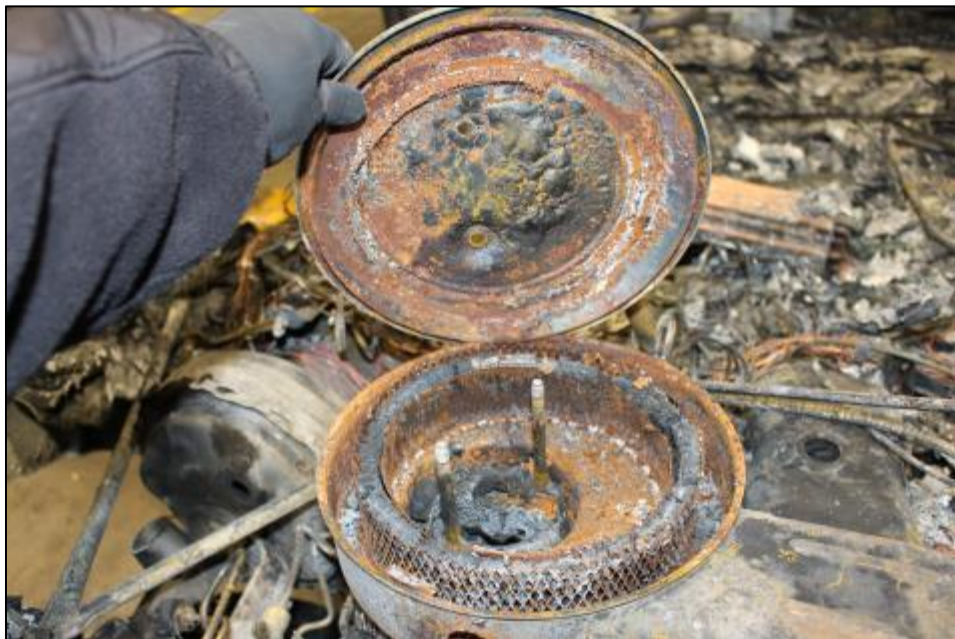
Photograph 10
Air Filter.

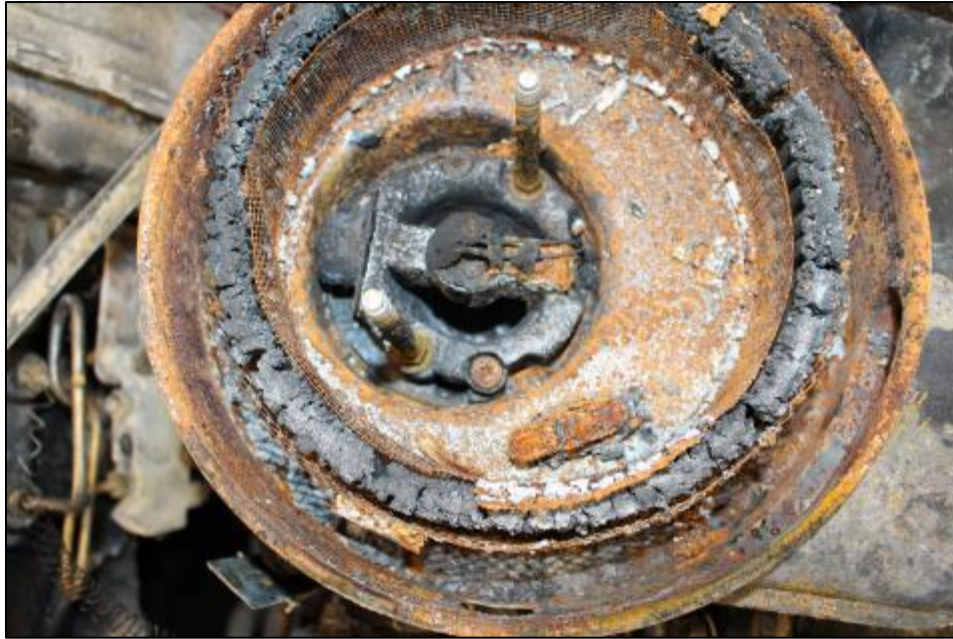
Photograph 11
Inside air filter.

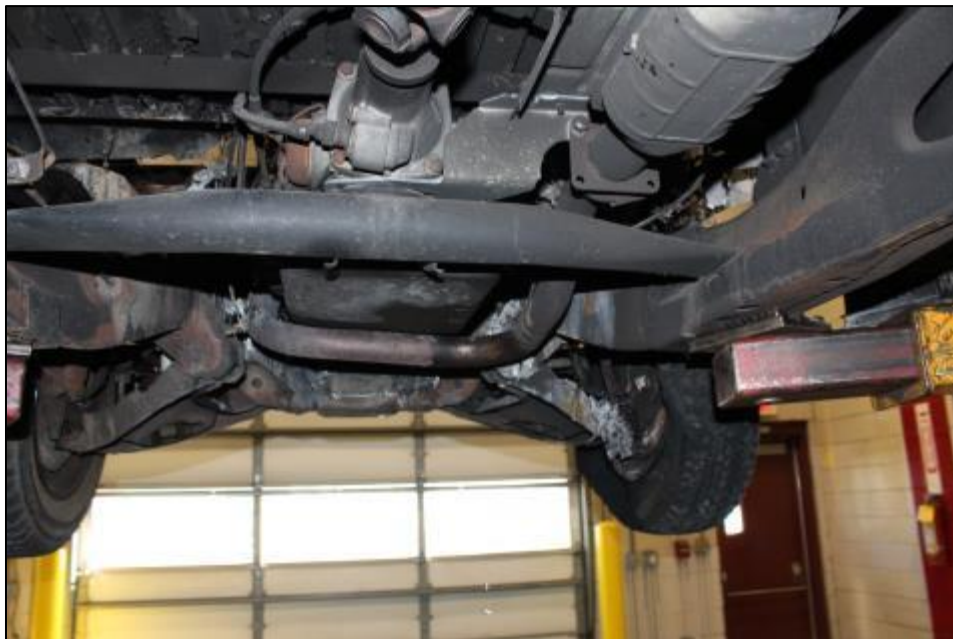
Photograph 12
Under carriage looking towards rear.

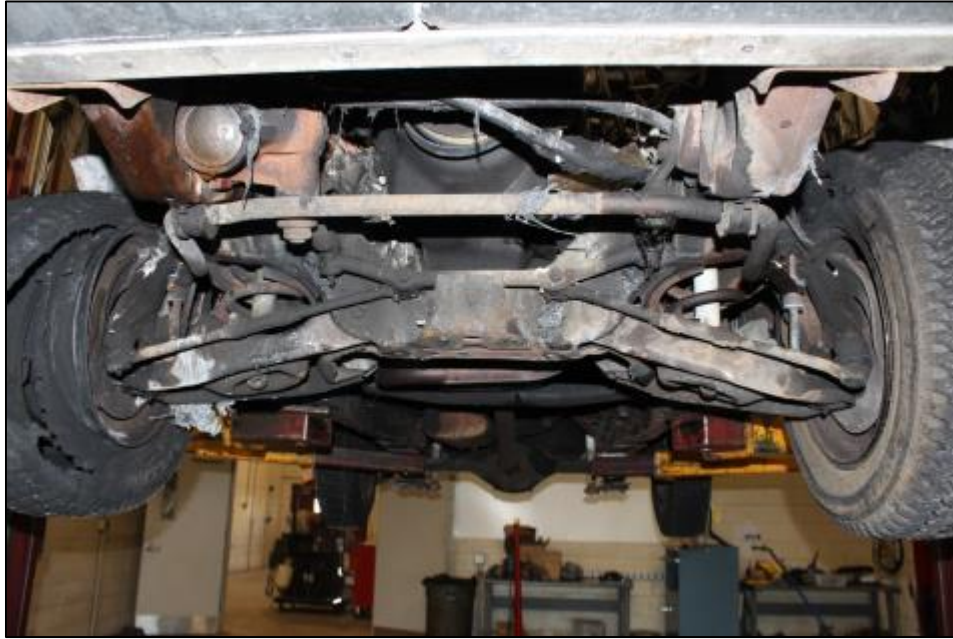
Photograph 13

Under carriage looking towards front.

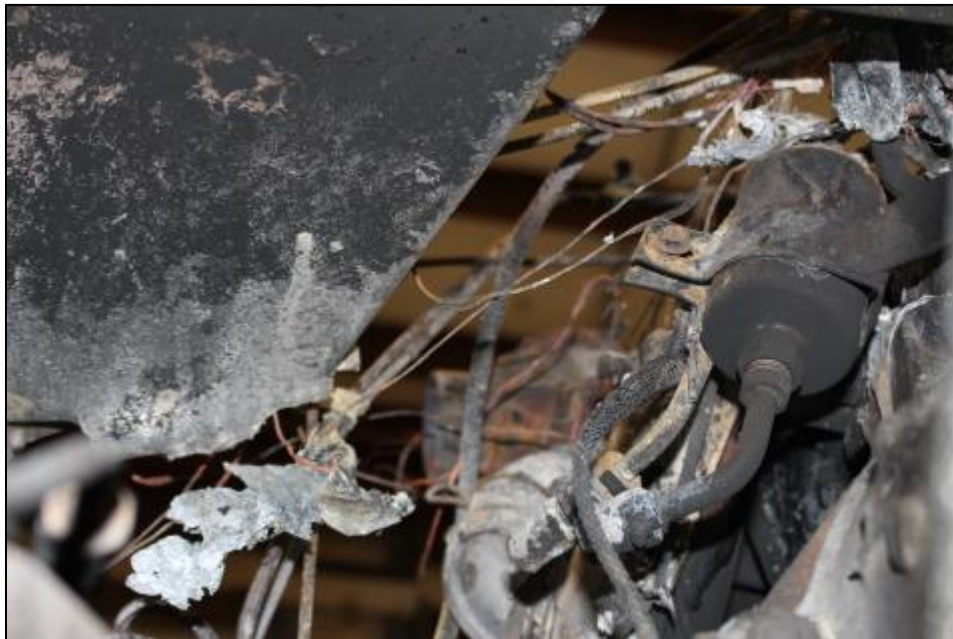
Photograph 14

Fuel filter on left side on engine.

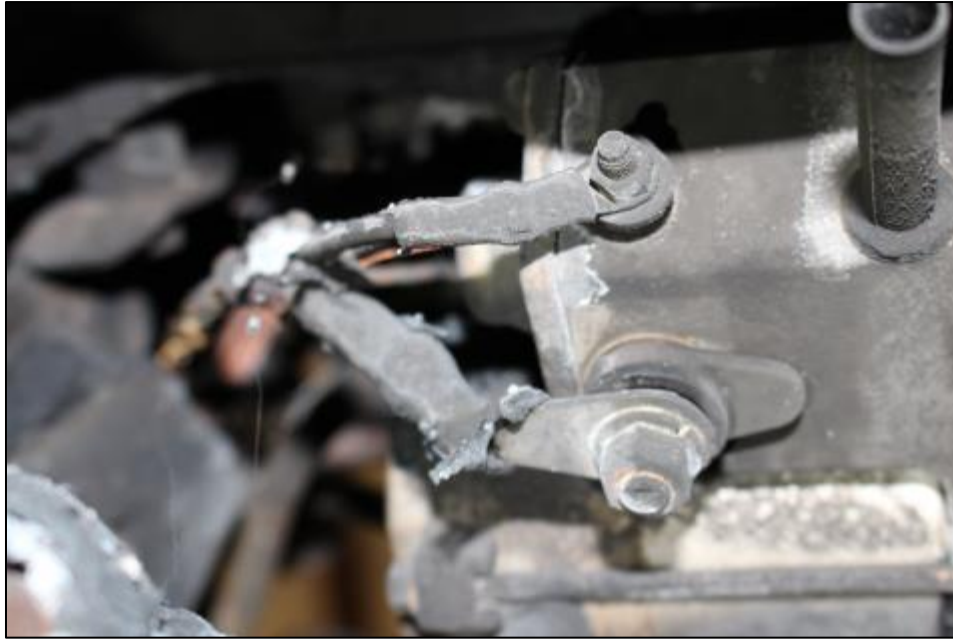
Photograph 15
Starter and conductors.

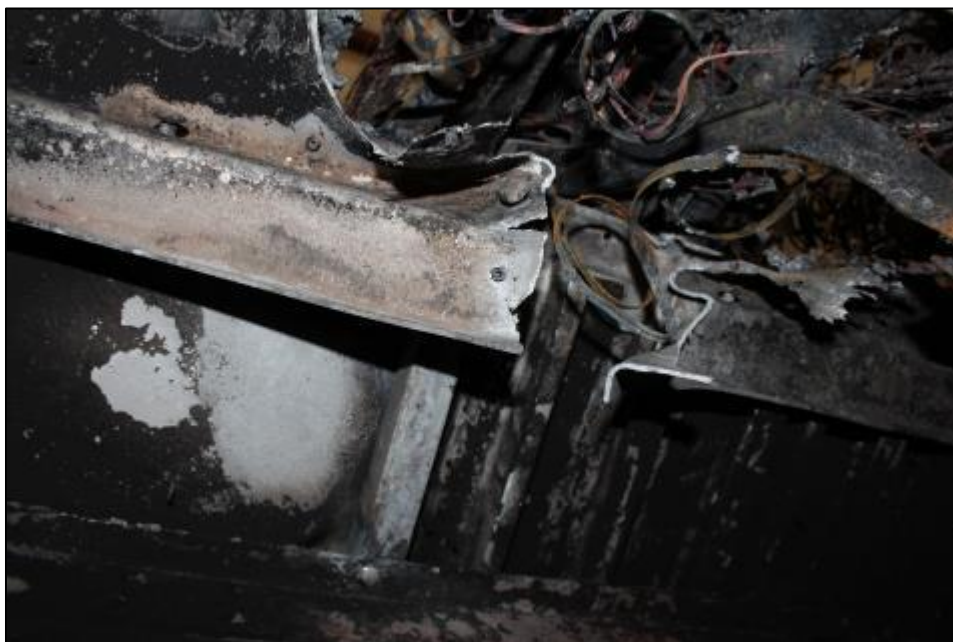
Photograph 16
Fire damage to metal decking on driver's side.

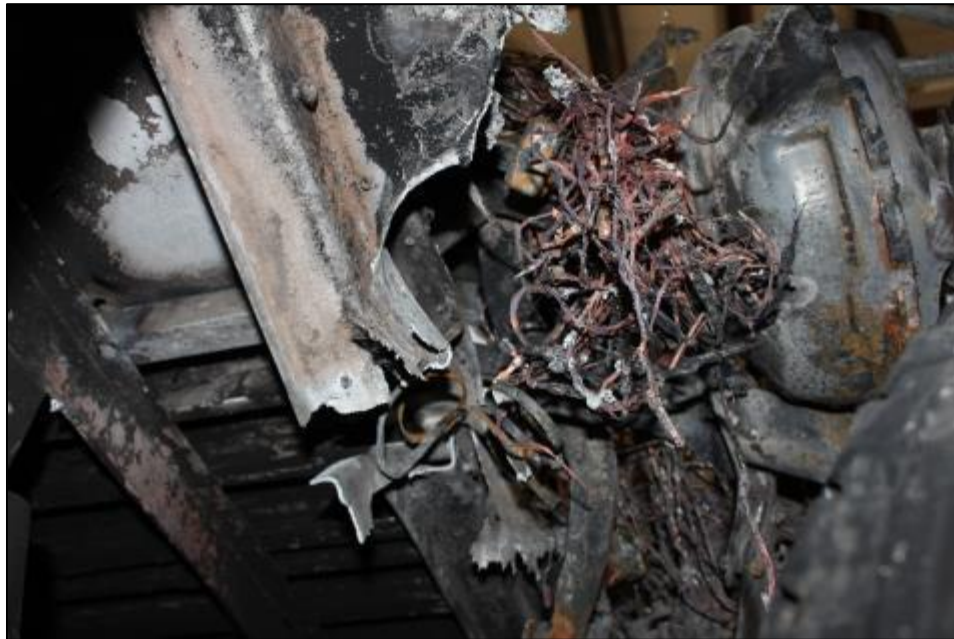
Photograph 17

Closer view of damage to metal decking on driver's side.
